Hydraulic Cylinder Case Study: A Mississippi machining & fabricating company

Backface cycle time sped up by 260%

Autofacer®

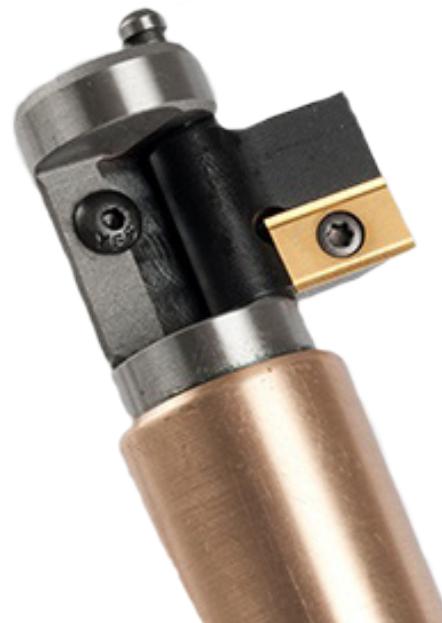
The original process consisted of (3) CT50 integral shank back boring bars. This tool used expensive inserts @ \$60 each that could only be ordered in packs of 50. The feature was a 70.75mm (2.785) bore reaching thru 55mm (2.17) to generate a 150 mm (5.905) spot face. The spot face also had a 6mm (.236) corner radius and a 4.5mm x 45° ID chamfer. This feature was machined in 3 steps and produced surface quality inconsistencies with blends between the 3 steps. Steiner process machined the complete feature (ID Chamfer, Spot Face & Corner radius) in one pass. The Autofacer was run at 150 RPM and a feed rate of 0.8 IPM.

The customer realized a cycle time savings of 45 to 60 minutes per part, making the Steiner Solution 2 to 2.6 times faster than the old process and at the same time reducing insert consumption by 90%, improving surface finish quality problems, and eliminating the high rejection rate.
