CASE STUDY: Hydraulic Cylinders & Finish Issues

A Mississippi machining and fabricating company

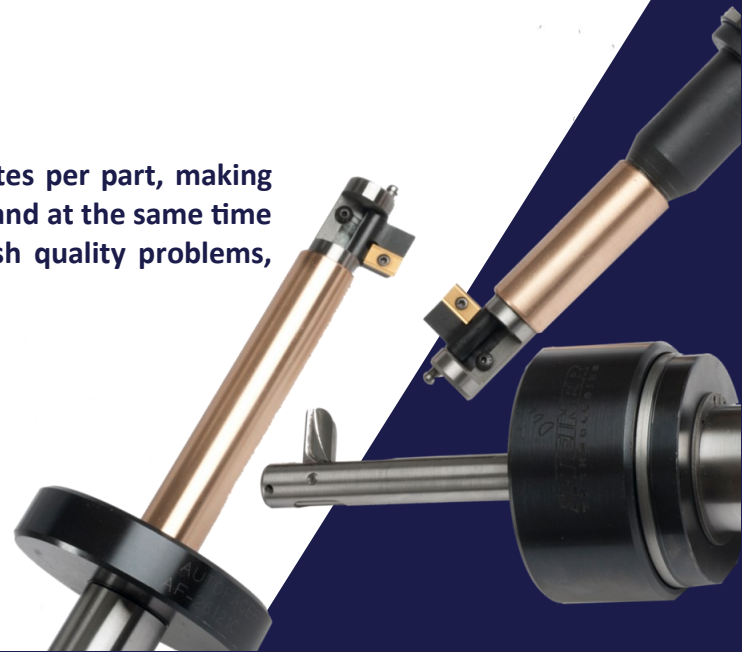
The original process consisted of (3) CT50 integral shank back boring bars. This tool used expensive inserts @ \$60 each that could only be ordered in packs of 50. The feature was a 70.75mm (2.785") bore reaching thru 55mm (2.17) to generate a 150mm (5.905") spot face. The spot face also had a 6mm (.236") corner radius and a 4.5mm x 45° ID chamfer. This feature was machined in 3 steps and produced surface quality inconsistencies with blends between the 3 steps. The Steiner process machined the complete feature (ID Chamfer, Spot Face & Corner Radius) in a single pass. The Autofacer was run at 150 RPM and a feed rate of 0.8 IPM.
